Manhole Inspection Summary

Manhole # S33II1023MH

Location Address: **4108 ST PAUL ST**

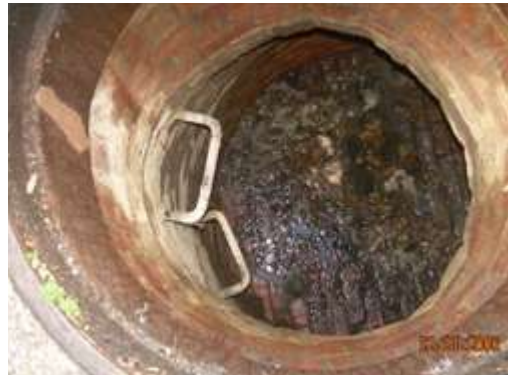
Top View

Channel Material: **Brick** ☐ Parged ☒ **Debris** (not Condition related)

Channel debris.

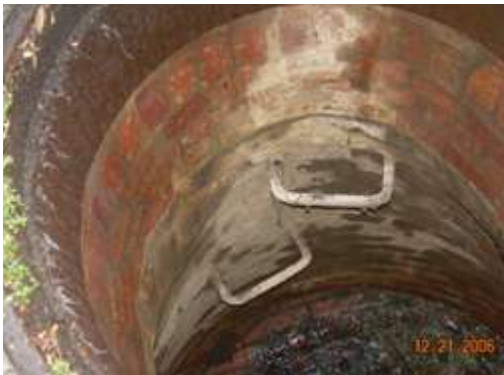
Defect

Infiltration: ☐ None ☒ **Joint** ☐ Cracks ☒ **Mortar** ☐ Roots ☐ Wall

Infiltration: ☐ None ☐ Joint ☐ Cracks ☐ Mortar ☐ Roots ☒ **Wall**

Infiltration: ☐ None ☐ Joint ☐ Cracks ☒ **Mortar** ☐ Roots ☒ **Wall**

Adjustment, Corbel, and Barrel infiltration.

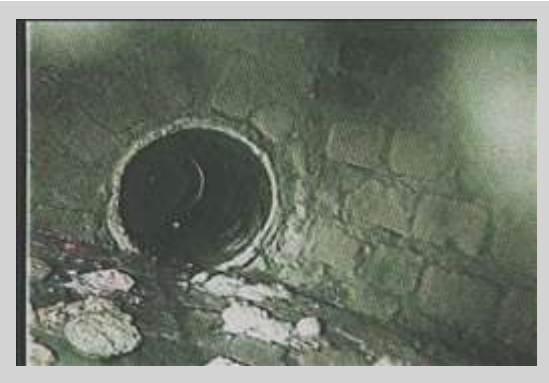
8 in. Circular Gravity Sewer Pipe Out @ 12 O'Clock

Infiltration: **Evidence** Pipe Seal Cond: **Cracked**

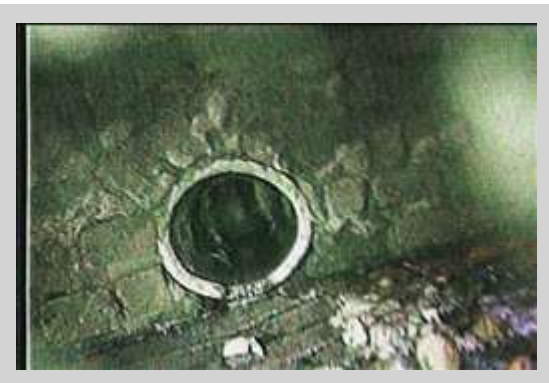
8 in. Circular Gravity Sewer Pipe In @ 4 O'Clock

Condition: ☐ Sound ☐ Cracked ☐ Root Intrusion ☐ Loose Brick ☒ **Deteriorated**

Barrel deterioration and infiltration.

Infiltration: **Evidence** Pipe Seal Cond: **Cracked**
